**ILLINOIS AUTO TRUCK**  
COMPANY, INC.

**New  
Product**

## M-1875 Bell Housing Cover

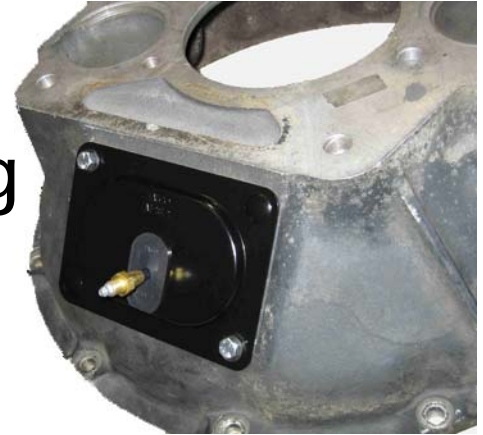
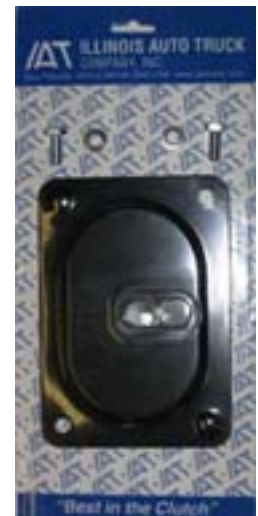
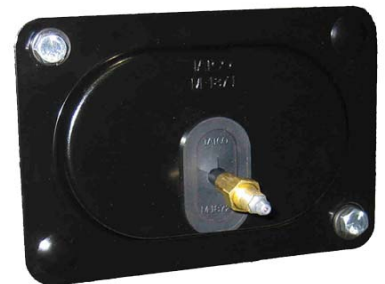
IATCO Assembly Number M-1875

Now, Illinois Auto Truck has the hand hole cover assembly available with a plug that will still allow passage of the grease hose while sealing the oversize hole in the hand hole cover to discourage the entry of the contaminants.

Simply insert the grease hose through the hole in the plug, attach the hose fitting to the clutch bearing housing assembly, and attach the hand hole cover to the clutch bell housing.

This assembly replaces OE number 4305230, and includes the cover, plug, mounting screws, and lock washers.
